## RETROFITTING VENTILATION INTO LOW-RISE HOUSING

A research project was undertaken to find, test and verify methods of retrofitting ventilation into low-rise housing. The purpose of this project was to identify effective and economical retrofit ventilation systems and evaluate their performance. Ten example systems were investigated. The results of this project will provide industry with retrofit ventilation ideas.

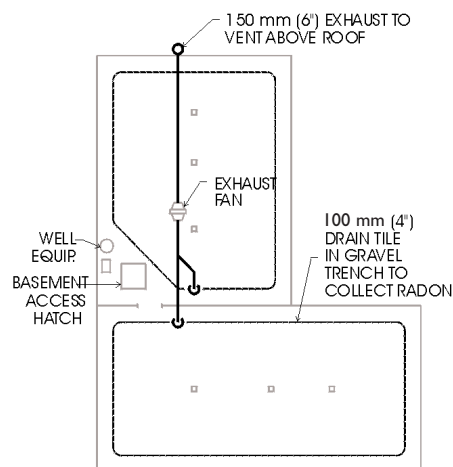
**Radon Removal System**

The homeowners were concerned with high concentrations of radon gas (a known carcinogen) measured within their house.

Radon gas concentrations were measured using an electronic monitor manually read three times per day, and were reduced from 15.8 pCi/L ("picoCuries per Liter") to 1 pCi/L, a reduction of almost 95%. The current measured level within the house is well under 21.6 pCi/L—the Canadian guideline, and 4 pCi/L—the American guideline for indoor environments. A combination of sub-surface depressurization and sealing the surface of the crawl space significantly reduced radon concentrations while surface sealing alone did not.

The entry of soil gas into crawlspace under house was minimized by sealing major migration locations, including the soil surface, using polyethylene sheeting, and sump lid and crawl space hatch using tight-fitting gaskets. Additionally, soil gasses from under the sealed polyethylene sheeting were collected in a stone-filled trench and perforated piping and exhausted by a fan.

Trenches were dug in the crawlspace following the house perimeter. A 100-mm (4") diameter perforated weeping tile was installed in the bottom of the 300-mm (12") wide x 200-mm (8") deep trench. The weeping tile was encased in pea gravel filling the trench.

The weeping tile was connected to the suction side of an in-line centrifugal fan rated 66 L/s (140 CFM) at an external static pressure of 187 Pa (0.75" W.C.). Soil gasses captured by the perforated weeping tile were exhausted outdoors through a 150-mm (6") diameter duct that extends above the eaves.

The surface of the soil was covered with 6-mil polyethylene sheeting. All the joints in the sheeting were sealed with an acoustical sealant and the edges of the sheeting were sealed to the foundation walls. The sump-pit lid and access hatch cover were sealed using airtight gaskets.

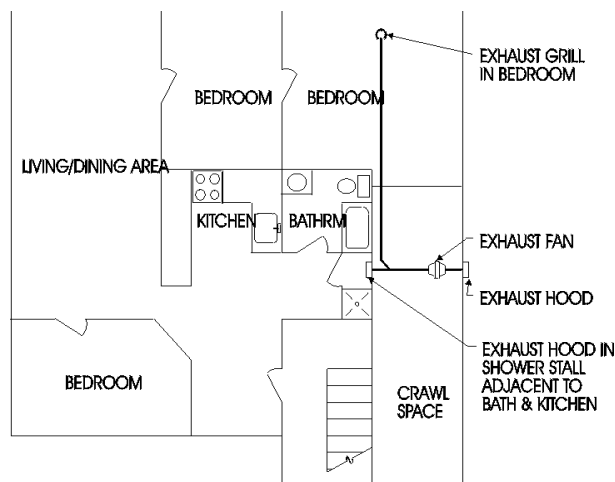
**Exhaust Layout**

The homeowner was concerned about the indoor air quality in their basement apartment. Tenants complained of odour and moisture build-up. Cooking odours from the basement apartment were also noticeable on the main floor.

The ventilation retrofit reduced overnight build-up of CO<sub>2</sub> by approximately 45%. The tenants confirmed that the air in the basement apartment seemed fresher and less humid. There have been less odours coming from the apartment since the retrofit.

An exhaust-only ventilation system was installed with multiple pick-up points dedicated to the basement apartment. The system exhausts air from the basement and draws air down from the main floor, changing natural ventilation flows in the house. The system introduces ventilation into the basement while simultaneously reducing exfiltration through upper parts of the house. The new ventilation rate is less than the sum of the original infiltration rate and mechanical ventilation added.

A 100 L/s (210 CFM) exhaust fan was installed in a crawlspace adjacent to the basement apartment. Two exhaust grilles were installed—the first in a shower stall and the second in a bedroom. To minimize operating costs, the exhaust fan operates on an event timer based on the occupant’s weekday (on at 4:00 p.m.; off at 8:00 a.m.) and weekend (24 hrs/day) schedule.

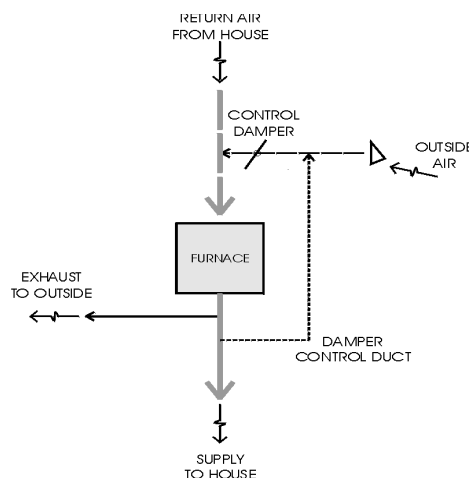
**Fresh Air Control System**

Occupants were concerned that health symptoms were caused by insufficient ventilation resulting in poor indoor air quality.

CO<sub>2</sub> tracer gas measurements show that even a leaky house has virtually no ventilation on mild, calm days, that mechanical ventilation can introduce adequate levels of ventilation, and combining mechanical and natural ventilation can produce higher air exchange rates than either alone.

An outside air duct was connected to the furnace return to provide outdoor air to the house. The “Fresh Air Control System” (Wait Model 970) is a heat-activated damper that opens the intake duct only when the furnace is operating. An exhaust duct to outside from the furnace supply duct was installed without a damper.

A 150-mm (6") diameter insulated duct is connected from an outdoor hood to the furnace return. A 100-mm (4") diameter uninsulated duct is connected from the supply air duct to the outdoors. The furnace fan operates continuously at low speed, cycling to high speed on a call for heating or cooling. The “Fresh Air Control Damper” is installed in the fresh air intake duct just upstream of the furnace return. When the damper is not activated, it is held open at a minimum setting to allow some fresh air to be drawn in.

A 75-mm (3") diameter bypass duct runs from the furnace supply air duct to the “Fresh Air Control Damper”. Air continuously circulates through this bypass duct passing over a bimetal operator in the damper. During a heating cycle, the heated bypass air causes the bimetal operator to open the damper blade so a larger volume of make-up air is then drawn into the furnace.

The 100-mm (4") diameter exhaust provides relief of over-pressure in the house caused by the intake duct. It is recognized that during certain points of operation, some heated house air is exhausted.

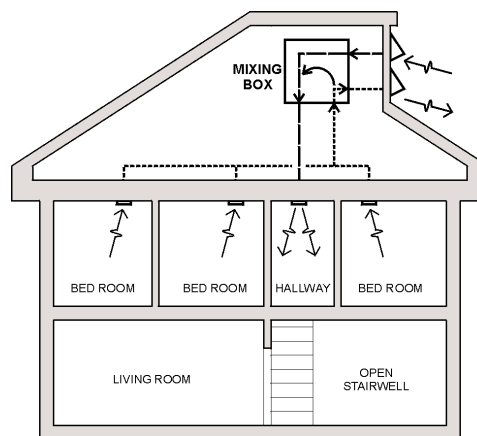
**Mixing Box Installation**

The homeowners identified indoor air quality as a concern based on excessive condensation on the windows and mold growth in the second floor bedrooms.

A CO<sub>2</sub> concentration reduction of almost 50% was found after the mixing box was switched on. Bedroom temperatures were reduced slightly during this relatively mild period. Calculations show that the tempered air at -20°C outdoor conditions could be delivered at under 10°C possibly causing cold drafts. Consideration should be given to issues such as equipment serviceability and potential duct leakage for any equipment that may be installed in an attic.

A “Mixing Box” ventilator (Nutech VentMax air exchanging ventilator) with ventilate/recirculate functions was mounted in the attic. A humidity control is used to activate the “ventilation” function on demand.

Air is drawn from the three bedrooms on the upper floor and supplied to the upper floor hallway when in recirculate mode. If the humidity rises above the set-point of the hallway-mounted controller, the ventilator switches from low to high airflow and opens the outdoor damper. Outdoor air is blended with the air being recirculated from the bedrooms. A portion of the blended air is exhausted outside to balance the ventilation flow. When humidity falls below the set-point, the unit returns to low speed, and closes the outdoor air damper.

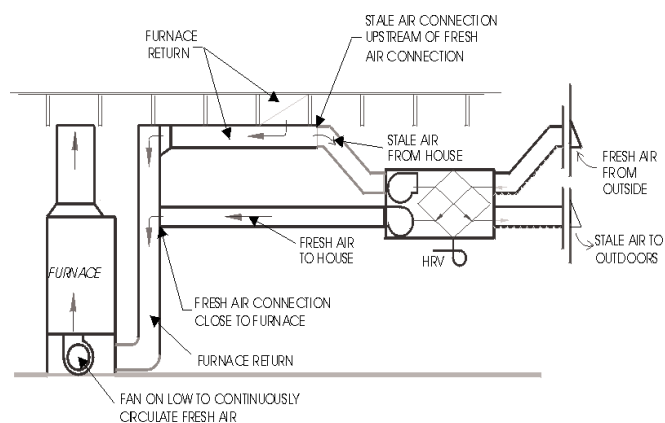
**HRV Retrofit**

The homeowners had concerns about poor indoor air quality based on a perceived air staleness and excessive humidity.

Quantitative results show an average 15 L/s increase in ventilation air supplied to the house and a 14% decrease in CO<sub>2</sub> concentrations. Quantitatively, the homeowners found that humidity levels in the house were reduced as condensation was practically eliminated from windows and the bedrooms felt fresher. This suggests that the increased ventilation resulted in an overall increase in indoor air quality. Ventilation air was effectively distributed throughout the house and the homeowner now has the ability to automatically or manually increase ventilation based on the humidity or other comfort factors. Heat recovery reduces annual operating costs while the continuous operation of the fan (which previously operated intermittently) increases them. An HRV is a relatively expensive piece of equipment but in the long run, heat recovery does have a payback.

An HRV was retrofitted to provide balanced mechanical ventilation with heat recovery. The furnace fan and supply ducting was used to effectively distribute fresh air to every room in the house.

A standard HRV was installed in the basement with outdoor supply and exhaust hoods installed through the rim joist. Fresh supply air and stale exhaust air are both connected to the existing furnace return duct with the exhaust connection being upstream of the supply to eliminate short circuiting. Distribution of fresh ventilation air occurs via the furnace supply ducting using the furnace fan on low speed continuously. The HRV is operated on low speed for 20 minutes per hour and is turned off for 40 minutes. A dehumidistat turns the HRV on high speed when humidity levels rise.

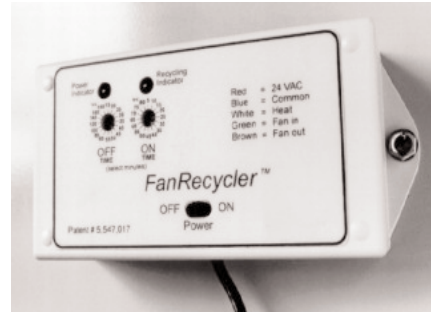
**Furnace Fan Cycling Control**

Homeowners are concerned with possible poor indoor air quality in basement bedrooms based on mold odours and stuffiness.

Efficacy was quite good with overnight build-up of CO<sub>2</sub> concentrations reduced by 25%. The homeowners believe that other airborne contaminants such as humidity and odours have also been reduced significantly. Basement contaminant levels are reduced as air throughout the house is mixed. Contaminants are then carried out of the house with air exfiltrating from the main floor.

The leaky house had abundant levels of fresh air on main floor. Turning on the furnace fan mixed the house air, introducing fresh air from the main floor into the poorly ventilated basement. This was done by intermittently activating the furnace fan using a furnace fan cycling control.

A commercially available special-purpose controller is retrofit to the furnace. The controller operates the furnace fan intermittently. The house air is mixed and turned over. Fresh air from the main floor is introduced to the basement. To avoid excessive fan operation, the controller turns the fan on only if the thermostat has not activated heating or cooling during the previous OFF period.

Fan on and off times are independently adjustable. The initial setting chosen was 10 minutes ON and 50 minutes OFF.

Higher efficacy could be achieved through longer fan run times. Increasing fan operating time would have an impact on the annual operating costs proportional to the increase in annual operating hours.

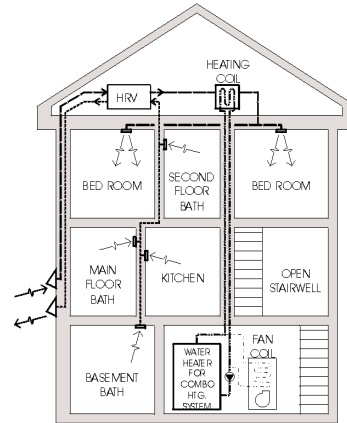
**HRV Installation**

Homeowners wanted to ensure that an adequate supply of fresh air was being supplied to the house after an energy-efficient retrofit was completed.

Building shell airtightness was better than R-2000 requirements at 1.3 ACH<sub>50</sub> (Air Changes Per Hour). The ventilation system provided approximately a 50% reduction in CO<sub>2</sub> buildup on the second floor overnight indicating a significant reduction in indoor air contaminants. Installation of the HRV was in an inaccessible space making servicing especially difficult.

No radon was detectable with the ventilation system operating. However, when the ventilation system was turned off the readings rose to about 3.5 pCi/L, below the U.S. Environmental Protection Agency (EPA) recommended action level of 4.0 pCi/L and the Canadian guideline of 21.6 pCi/L.

An HRV was installed in a heated attic. Exhaust vents were installed in high humidity locations and supply air was provided to the second floor bedrooms only. Ventilation air was then drawn through the remainder of the house by suction from the exhaust vents.

A second-storey addition was retrofit on an existing bungalow. The addition included two bedrooms, a bathroom and an insulated attic area for mechanical equipment. The building was super-insulated and airtight. An HRV was mounted in the attic with ducting placed in the walls during the renovation. Space heating was provided to the bedrooms by having the HRV blow fresh air through a fan coil-fed from a water heater.

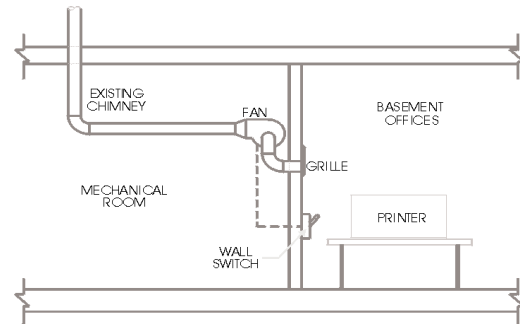
**Ventilation System**

Point source contaminants produced by home office equipment were compromising indoor air quality. Inadequate fresh air was being distributed throughout the house without mechanical ventilation.

CO<sub>2</sub> measurements show post-retrofit contaminant levels reduced by 30%. This mechanical ventilation system provides a continuous 0.48 ACH. Air quality in both the basement office and the remainder of the house has been significantly improved.

A dedicated exhaust fan for mechanical ventilation was installed with an exhaust grille mounted near the pollutant source. Depressurization provides fresh air through infiltration in other parts of the house.

A centrifugal fan provides 66L/s (0.48 ACH) of continuous exhaust from the house. Air is extracted from immediately behind the printer and is exhausted through an abandoned metal chimney. Fan size was chosen to allow continuous air change without over-ventilating. Use of the metal chimney was a convenient coincidence that reduced installation costs because no exterior penetration was required.

Possible variations include putting the fan on a manual switch or timer. This would allow fan operation to be controlled on occupancy or on a predefined use pattern. Reducing operating time provides ventilation only when required and minimizes operating costs.

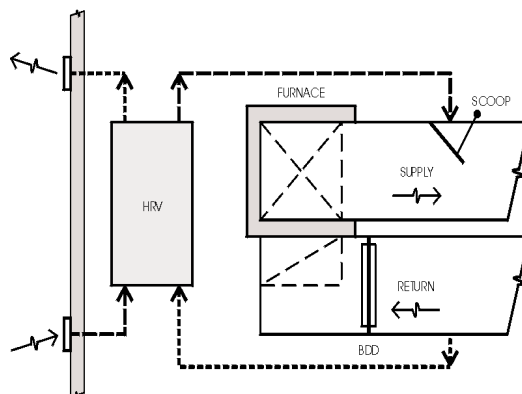
**Modified HRV Retrofit Installation**

Homeowners identified indoor air quality concerns based on stuffiness in bedrooms, condensation on windows and in exhaust ducts, and mold growth on the bathroom ceiling.

Carbon dioxide levels in the master bedroom were reduced from nighttime peaks of approximately 1,000 ppm to 500 ppm. Relative humidity in the space was reduced from nighttime peaks of approximately 45% to 35%. The occupants also reported a noticeable improvement in the freshness of the air in the house.

Install an HRV to provide balanced mechanical ventilation. This ventilation unit exhausts stale, moist air, and supplies fresh, dry air to the house. Heat recovery is used to minimize the costs of providing ventilation.

A residential HRV was installed in the basement near the furnace. Exhaust air was drawn from the existing furnace return to draw stale air from various parts of the house. To provide effective distribution of fresh air, the HRV supply duct was connected to the furnace supply duct. An adjustable damper was installed in the furnace supply duct over the opening for the HRV connection creating a venturi to keep the HRV flow from being affected by furnace fan operation. A backdraft damper was installed in the furnace return duct downstream of the HRV exhaust to prevent fresh air from short-circuiting through the furnace to the HRV exhaust when the furnace fan is off. Using only the HRV fan to distribute fresh air reduced operating costs.

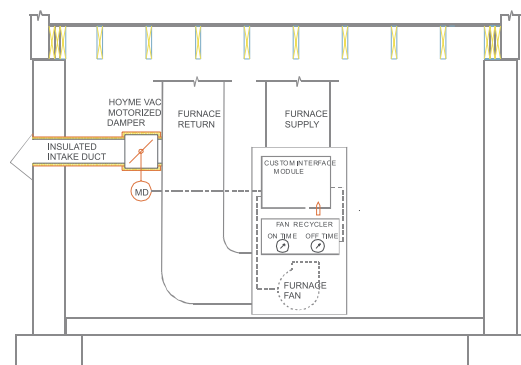
**Motorized Damper and Furnace Fan**

Homeowners were concerned with occasional backdrafting due to depressurization when the wood stove was started. They also wanted to add controllable ventilation to provide humidity control.

Peak CO<sub>2</sub> concentrations were approximately 50% lower than those recorded before the system was installed. This potentially represents a significant decrease in the concentration of indoor air contaminants.

An outside air intake duct with a “Hoyme-VAC” motorized damper was connected to the furnace return air duct. A “Fan Recycler” timer was installed to operate the furnace fan and motorized damper, providing ventilation air on a regular, periodic basis.

A 150-mm (6") diameter insulated duct and in-line motorized damper were connected from an outdoor intake hood to the furnace return. The furnace fan operates at low speed and the Fan-Recycler ensures the fan operates on high speed and opens the damper for a minimum 15 minutes of every 30 minutes. A custom interface constructed to adapt the Fan Recycler to the oil furnace allows the homeowner to choose between three modes of damper operation as listed below.
